Intel® Pentium® 4 Processor

Specification Update

July 2003

Document Number: 249199-039

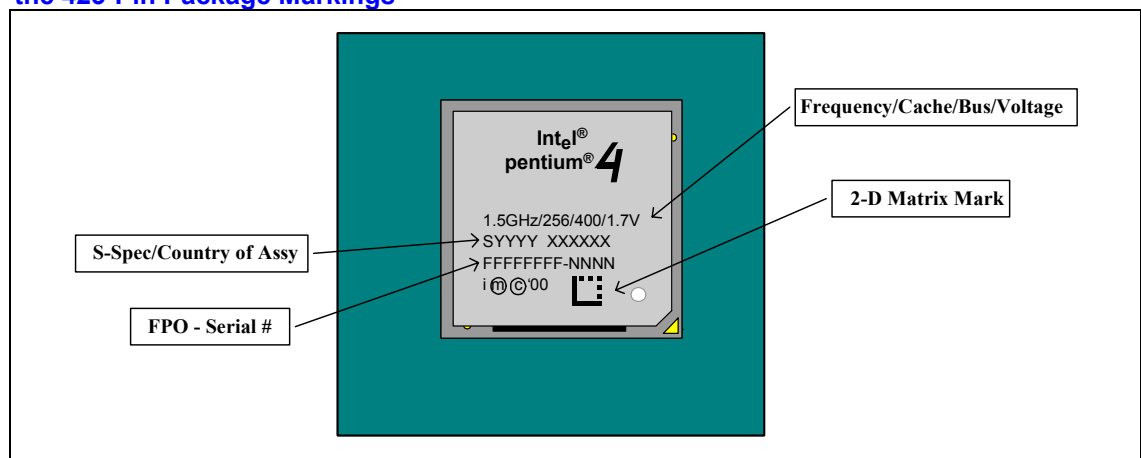
Figure 1. Intel® Pentium® 4 Processor in the 423-Pin Package and Boxed Pentium 4 Processor in the 423-Pin Package Markings

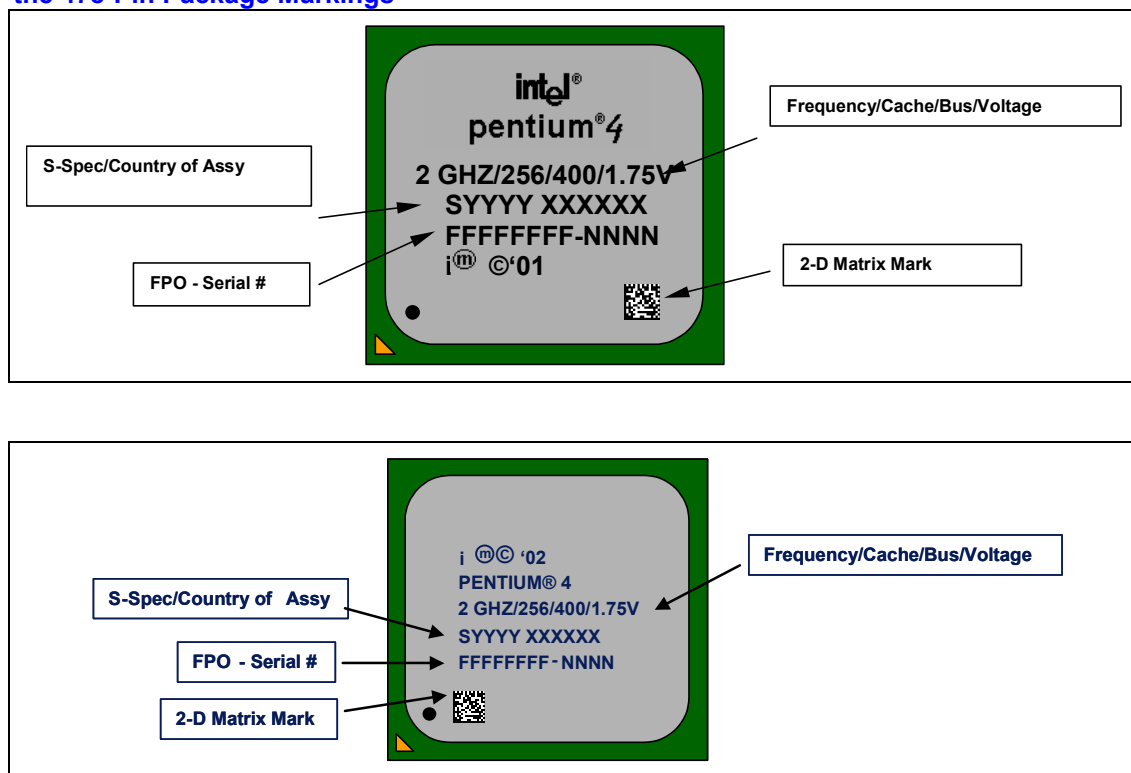
Figure 2. Intel® Pentium® 4 Processor in the 478-Pin Package and Boxed Pentium 4 Processor in the 478-Pin Package Markings

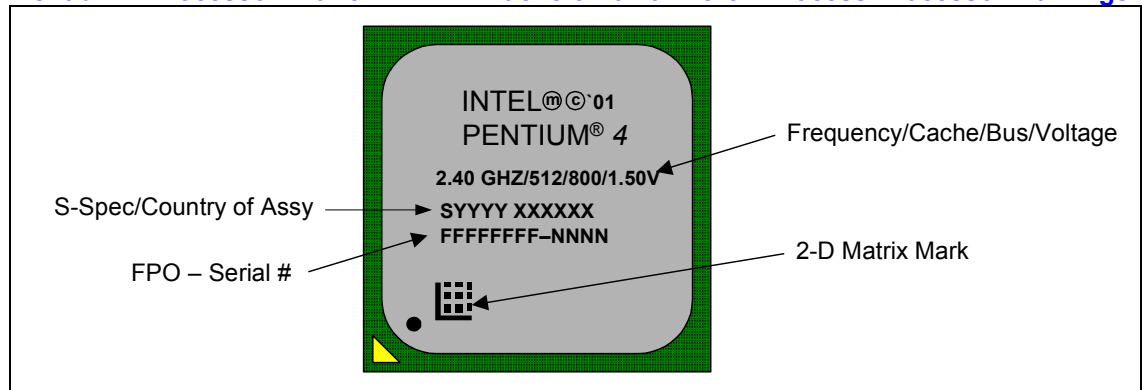
Figure 3. Intel® Pentium® 4 Processor with 512-KB L2 Cache on 0.13 Micron Process and Boxed Pentium 4 Processor with 512-KB L2 Cache on 0.13 Micron Process Processor Markings

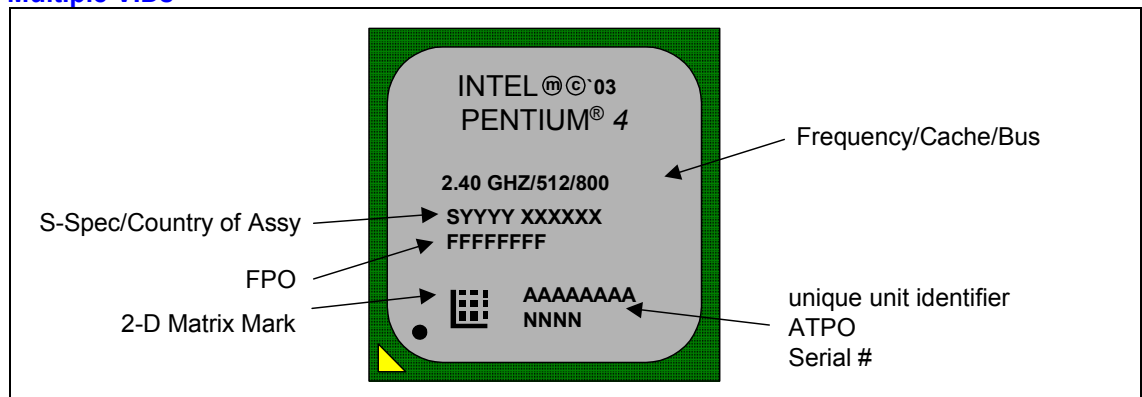
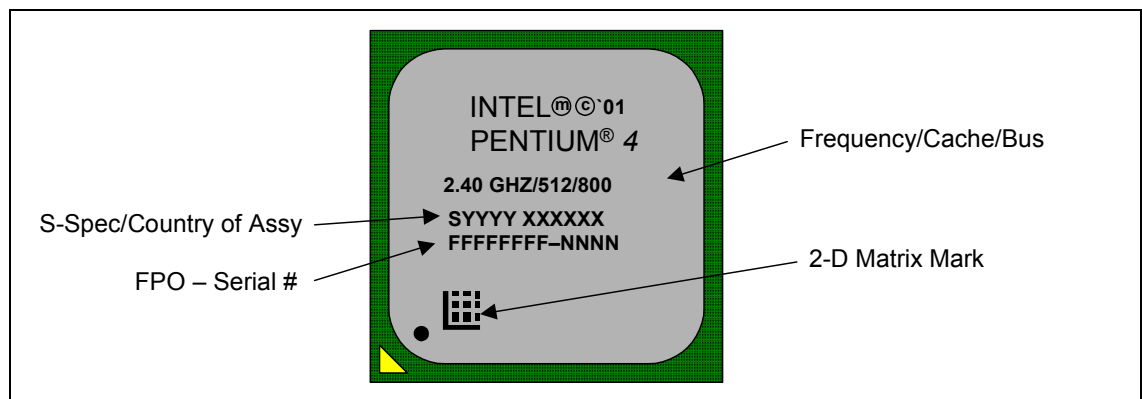
Figure 4. Multiple VIDs
